Re: Pesticide Remedial Investigation
Galaxy Landscape Company Nursery &
Landscape Center
Block 1402, Lot 7
Borough of Woodcliff Lake
Bergen County, New Jersey
Our File No. WL-942

Pursuant to your July 30, 2015 email, Boswell Engineering (Boswell) is pleased to provide this letter report associated with the environmental areas of concern (AOC) at the above referenced property.

ATTACHMENT C
Pesticide Vertical Delineation Plan

PESTICIDE VERTICAL DELINEATION PLAN
 223 WOODCLIFF AVENUE
 BOROUGH OF WOODCLIFF LAKE

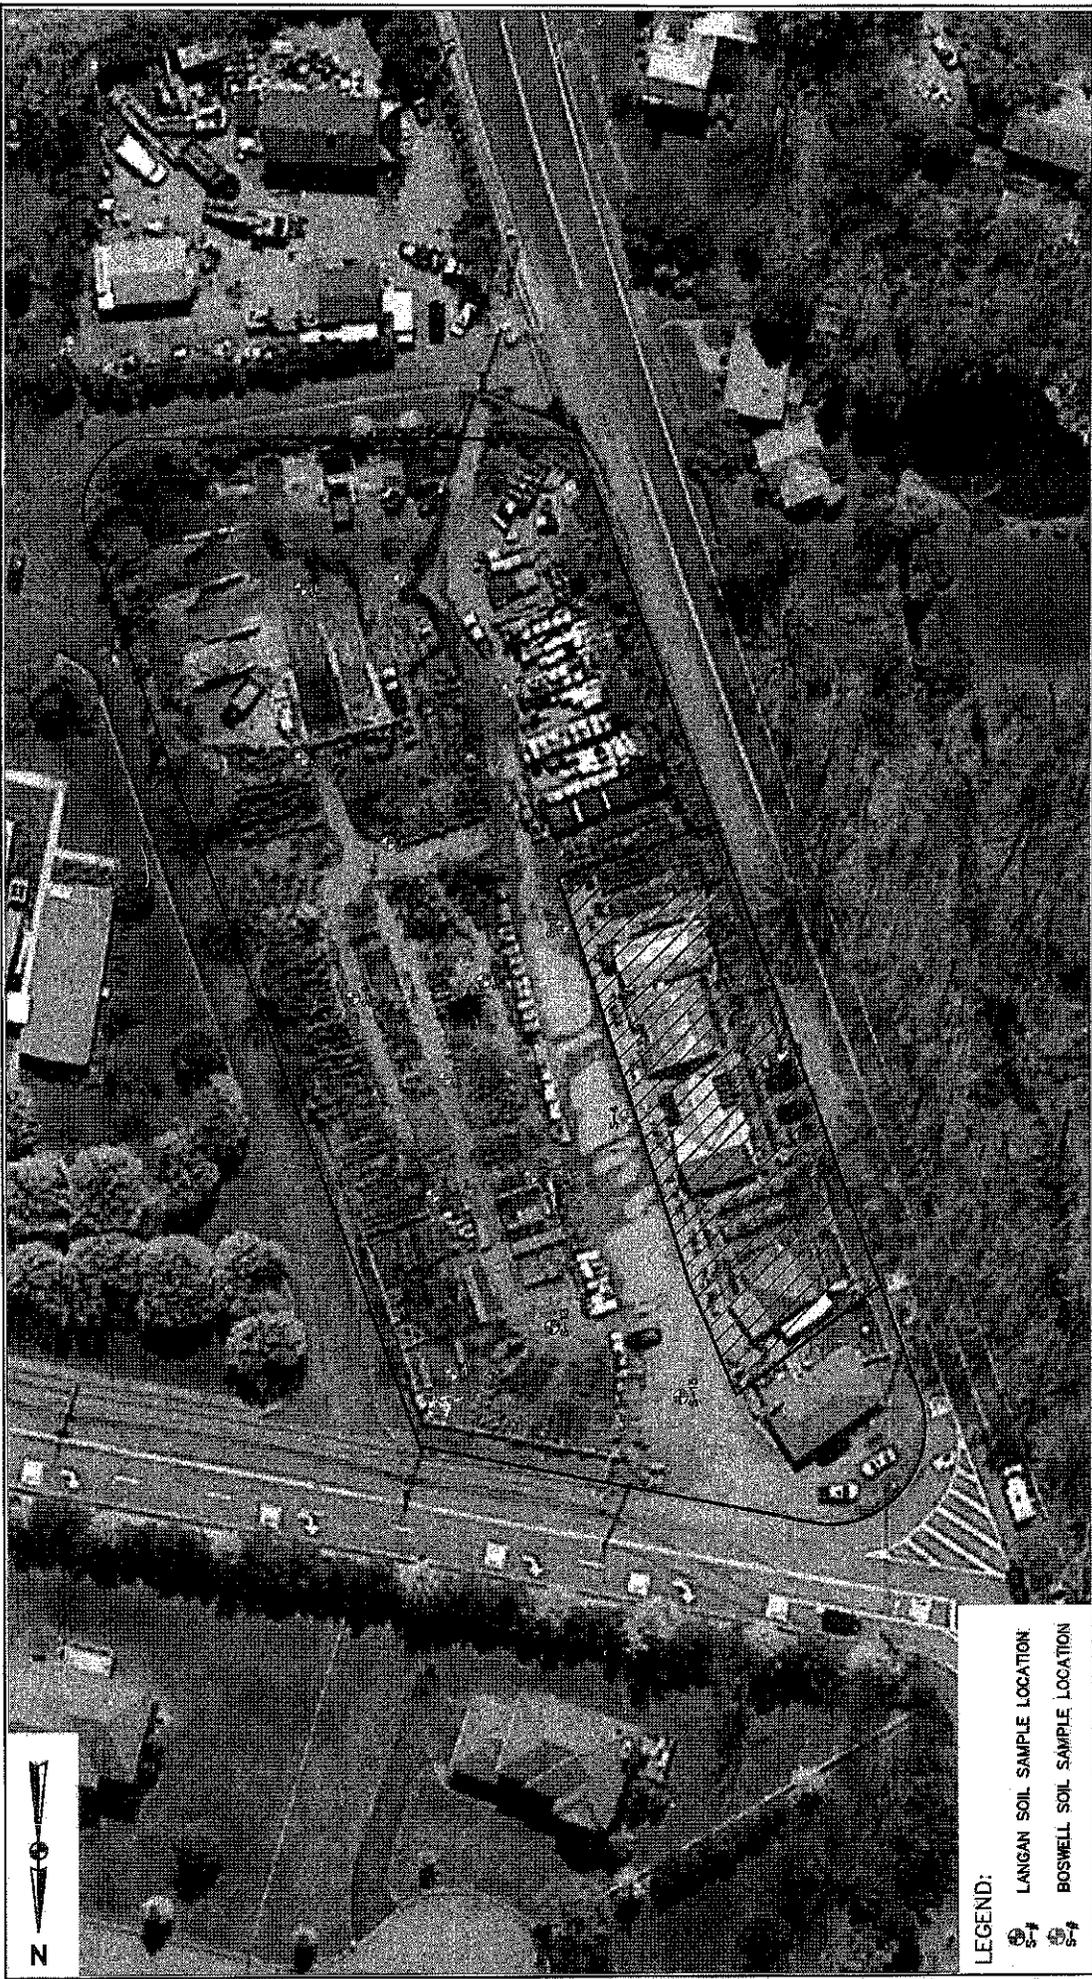
ATTACHMENT B
Sample Location Map

Boswell first established a sampling plan based on Langan's July 2014 Sample Locations and Exceedances Plan. We then instructed the contractor to advance 10 soil borings at Langan's previous sample locations. Two (2) samples were collected from each boring. The 6" soil interval was sampled from each 2.5'-3.0' and 3.5'-4.0' vertical depth. Initially, samples collected from the 2.5'-3.0' were analyzed for Target Compound List (TCL) organic pesticides. Samples collected from the 3.5'-4.0' were placed on hold pending the results of the shallower soil sample interval.

SOIL SAMPLE LOCATION PLAN
 223 WOODCLIFF AVENUE
 BOROUGH OF WOODCLIFF LAKE
 BLOCK 1402 LOT 7
 BERGEN COUNTY NEW JERSEY
 DRAWN BY: JAC DATE: 10/20/08
 CHECKED BY: JAC DATE: 10/20/08
 DATE: 10/20/08
 SHEET NO. 1 OF 1
 SCALE: 1" = 100'

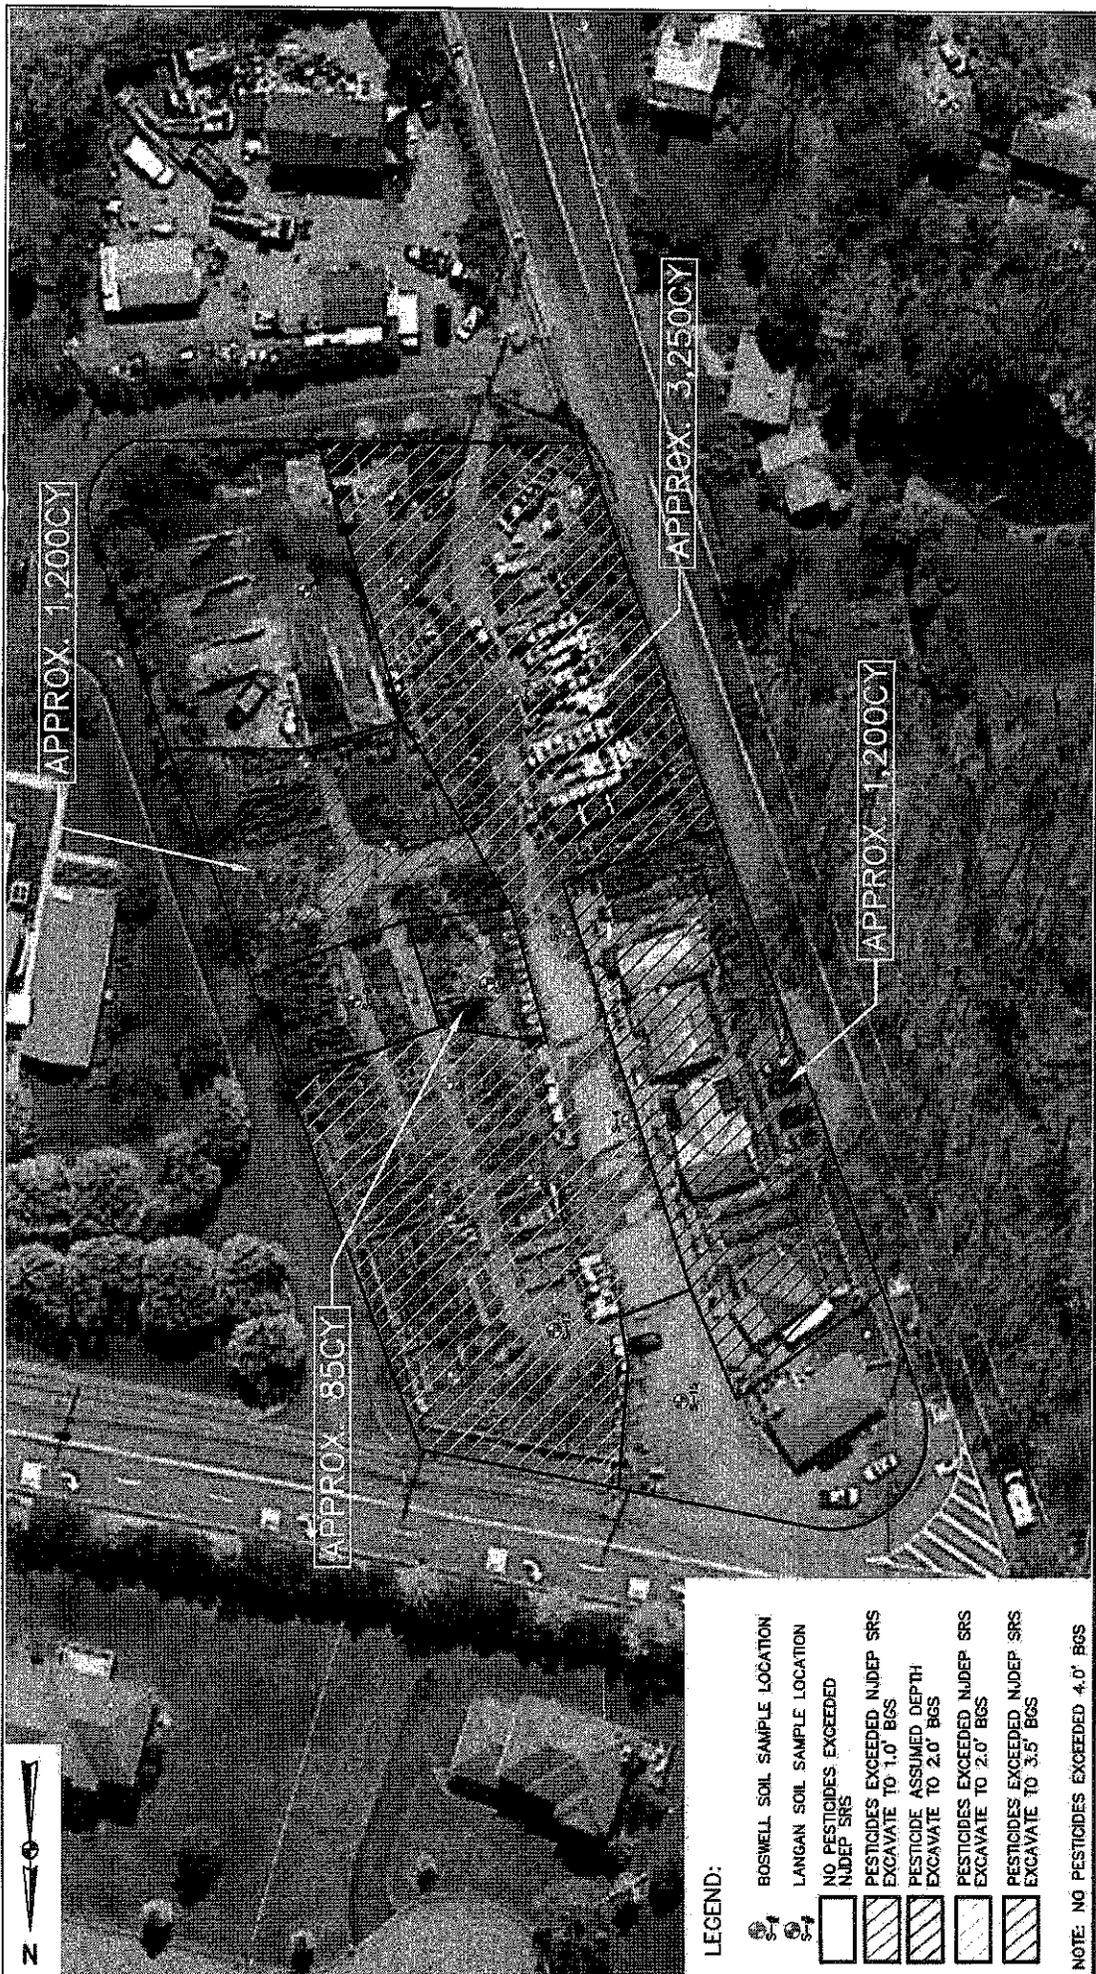
Based upon the sampling results, Boswell concludes that the site's pesticide contamination has been both horizontally and vertically delineated. Horizontally, the pesticide contamination extends to the property boundaries and vertically it does not extend past depths greater than 3.5'-4.0' bgs.

NOTE: NO PESTICIDES EXCEEDED 4.0' BGS

There are essentially three (3) options regarding the pesticide remediation, the first two (2), excavation and disposal or soil blending remediate the property to an unrestricted-use standard. The third, capping, remediates the site to a restricted-use standard.

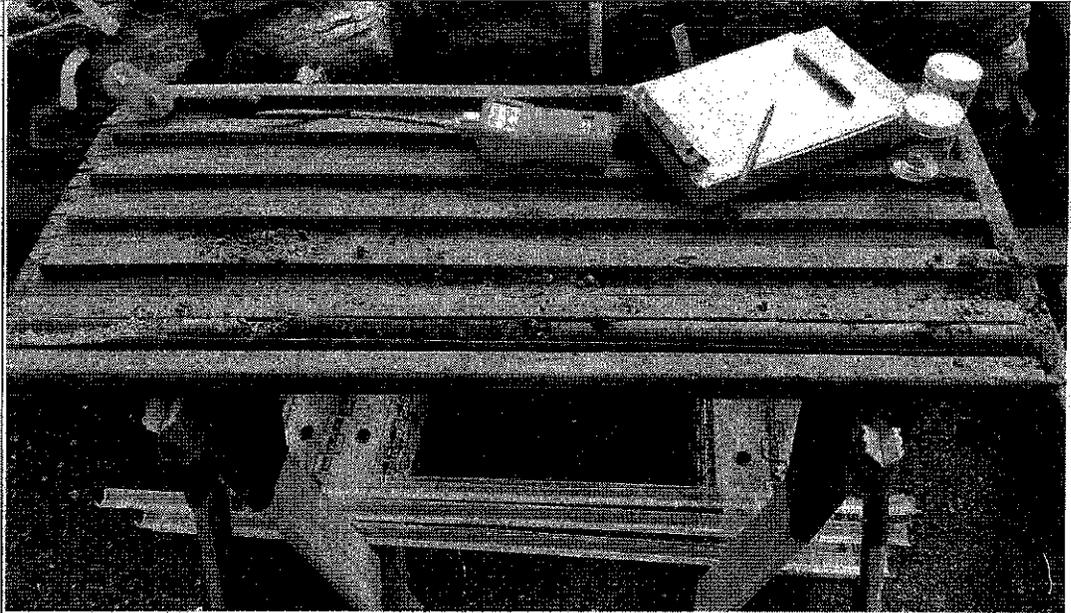
Photo No. 1.

Soil boring S-4. Soil cores were collected in 4' intervals and field screened at 1' intervals with a photoionization detector (PID).

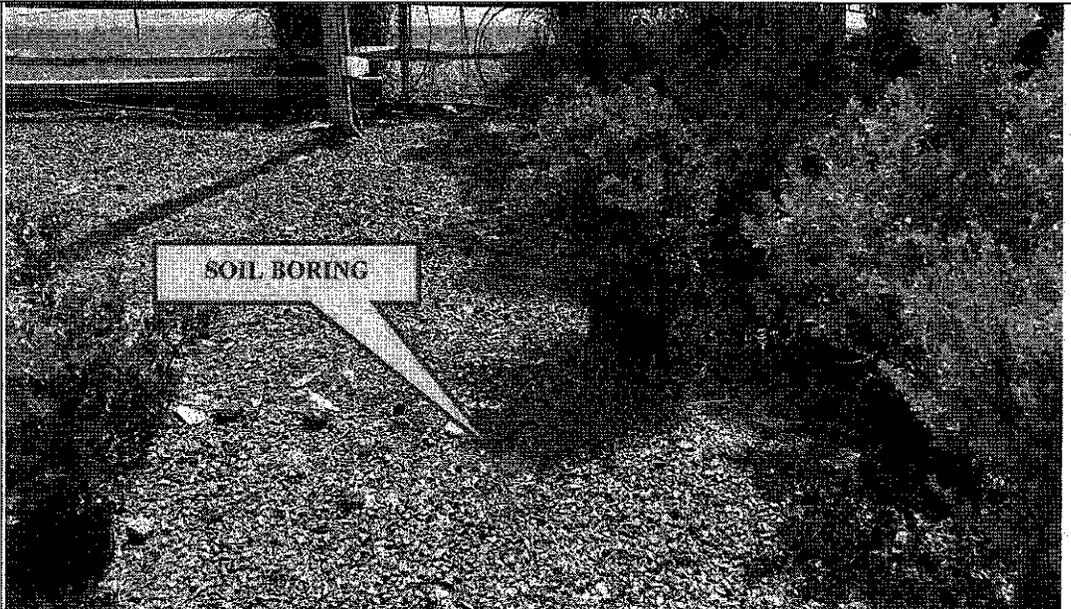
Photo No. 2.

Soil boring S-5 advanced in the northeast corner of the site, along Woodcliff Avenue.

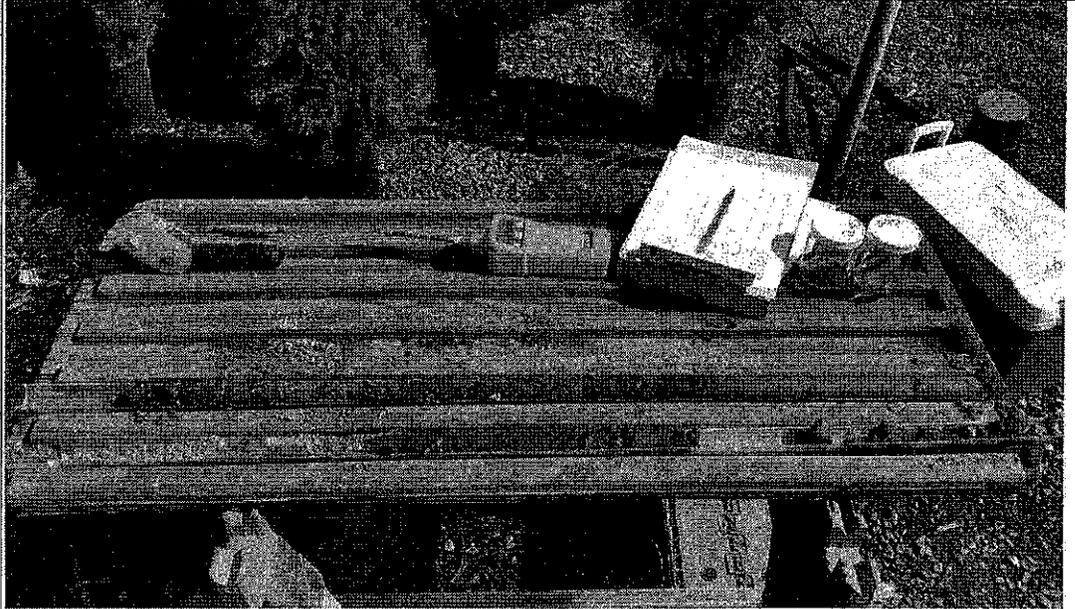
Photo No. 3.

Laboratory analysis of the site's soil identified pesticide concentrations above the most stringent NJDEP standards in samples S-6C and S-7C collected at a depth of 2.5'-3.0' in the central-eastern portion of the property. Specifically, the pesticides analysis identified alpha-chlordane, gamma-chlordane and dieldrin above their respective IGWSSL in sample S-6C. Alpha-chlordane and gamma-chlordane were also detected in sample S-7C at concentrations exceeding their respective RDCSRS. Total chlordane was detected in both samples S-6C and S-7C at concentrations exceeding the RDCSRS.

Soil boring S-7. The 6" soil interval was sampled from each 2.5'-3.0' and 3.5'-4.0' vertical depth.

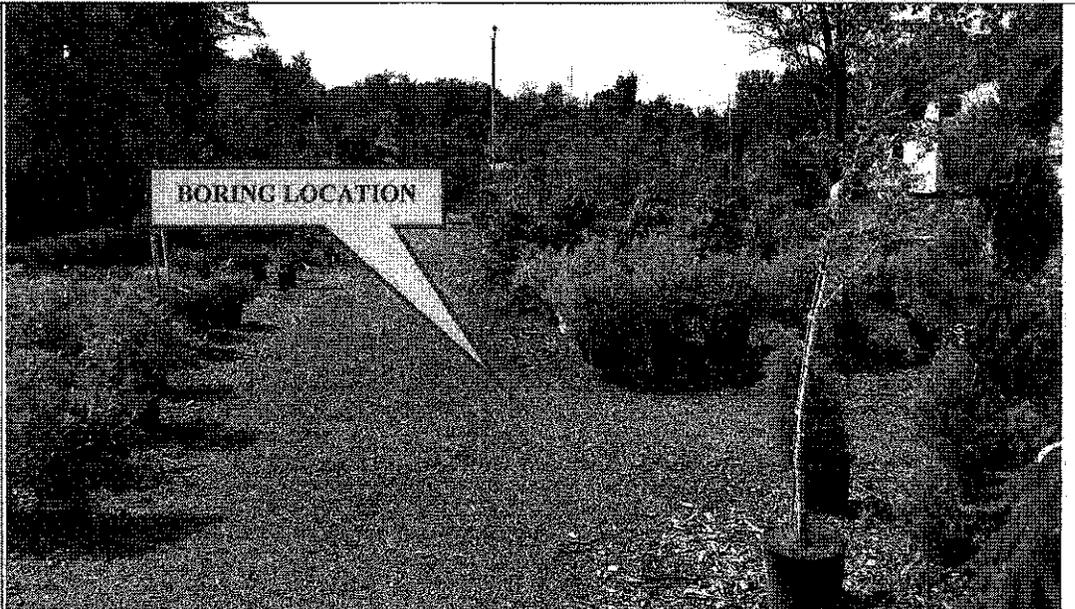
Photo No. 4.

Soil boring S-9 advanced at the central-eastern portion of the subject property.

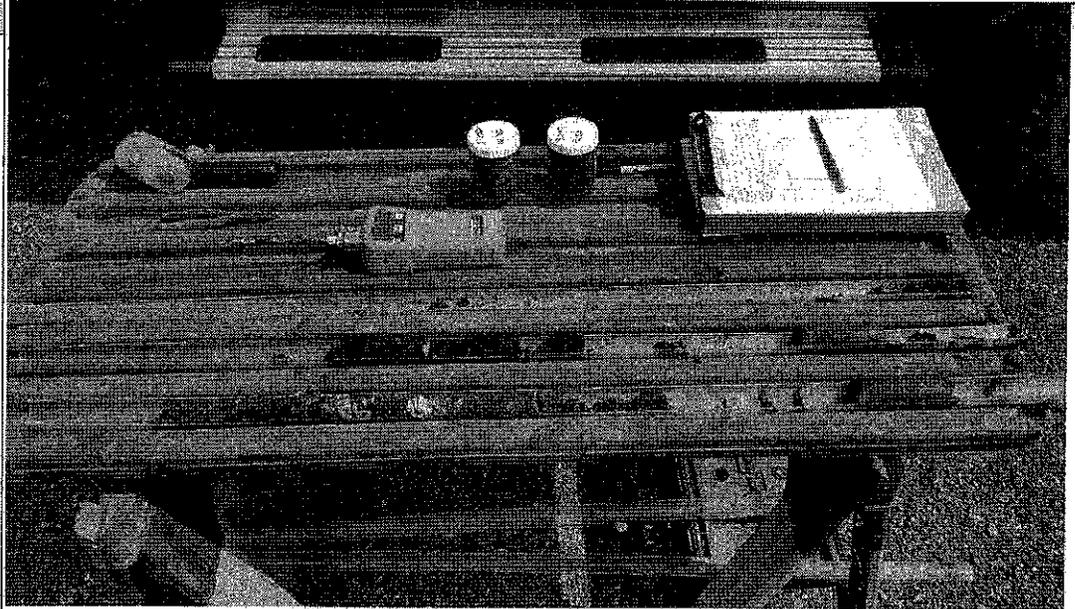
Photo No. 5

Soil boring S-14.

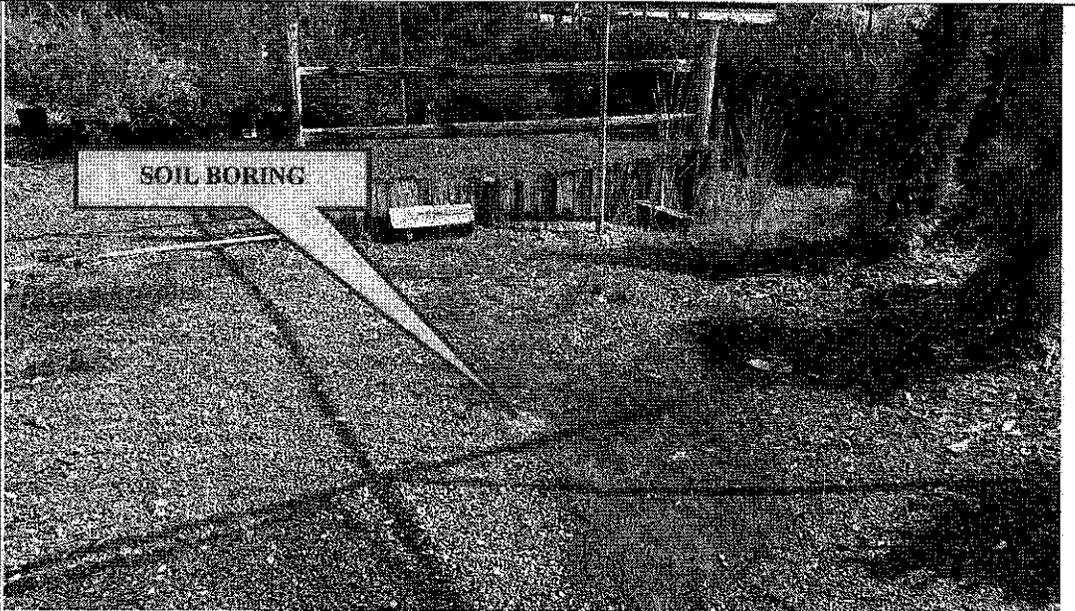
Photo No. 6

Soil boring S-14 advanced between borings S-5 and S-9, along the eastern portion of the site.
